Dual-Cure Light/Moisture-Cure Conformal Coating Technology

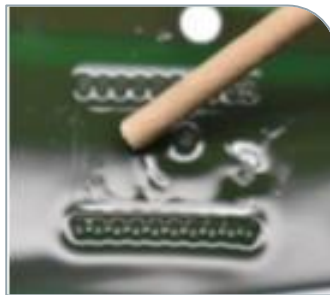
Figure 2. Control (5 minutes after cure)
Adhesive under component was completely wet

The images below show a PCB that was coated with a Dymax dual-cure conformal coating. Figure 1 shows the PCB component just after light cure. Figure 2 shows the area five minutes after light cure. The component was removed to inspect the shadow area beneath. The coating in this area was completely wet. 1 day later, as seen in Figure 3, moisture cure was in progress and the coating was soft but still wet.

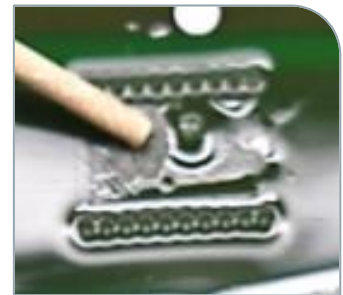
Figure 3. Day 1 at Room Temperature
Adhesive under component was soft and had a wet surface
